Building Works**The Client Requirements**

The client required us to complete building works at student accommodation in Birmingham. A new external drainage system was needed as the previous ACO drains had failed, which was causing major internal damp issues. The cellar walls then required tanking to prevent further water ingress. Whilst on site they also required new paving to cap the stairs, as they had become slippery and hazardous.

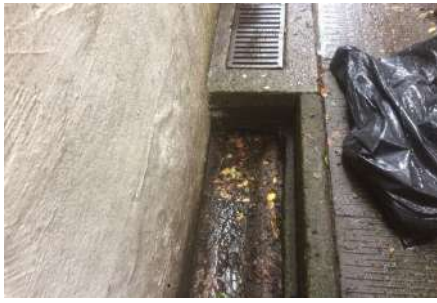
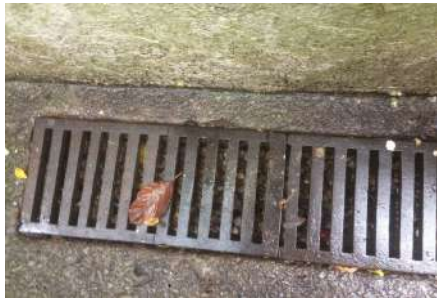
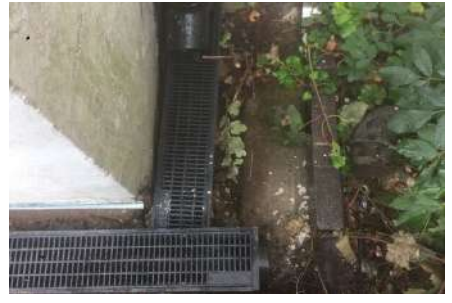
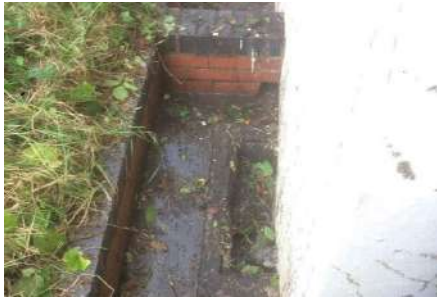
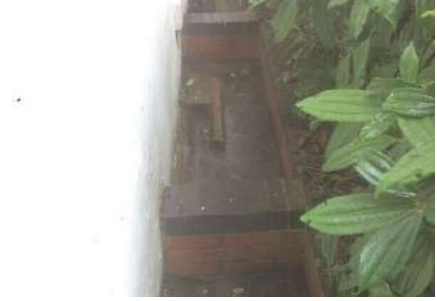
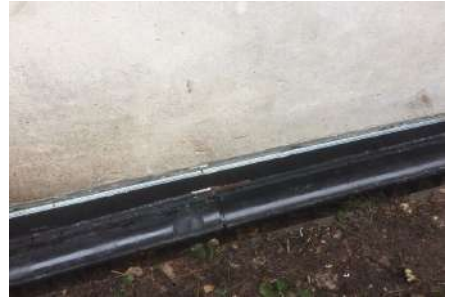
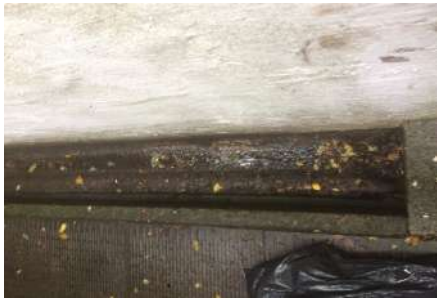
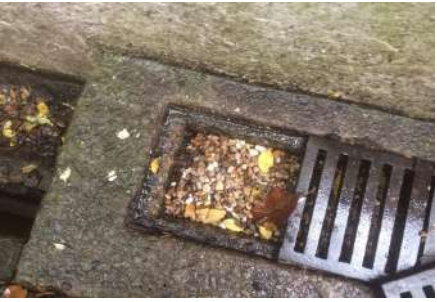
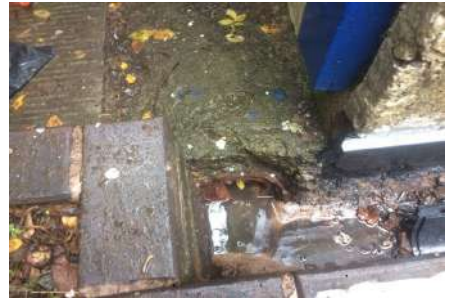
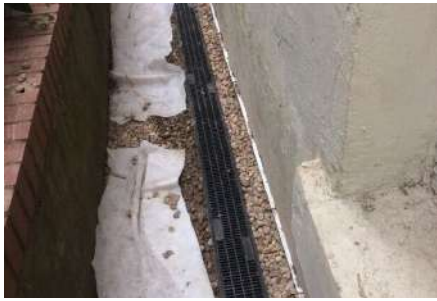
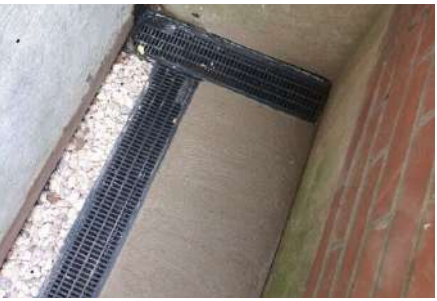
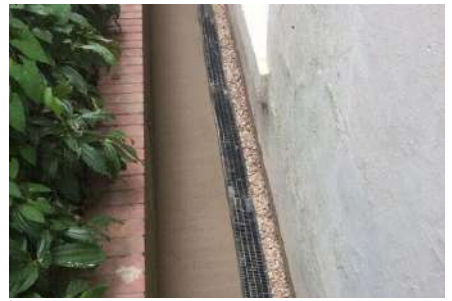
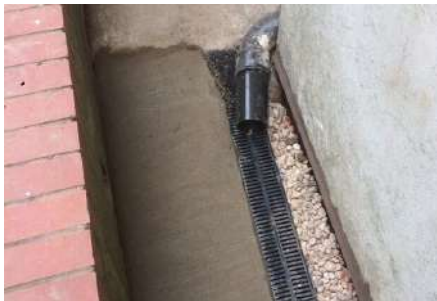
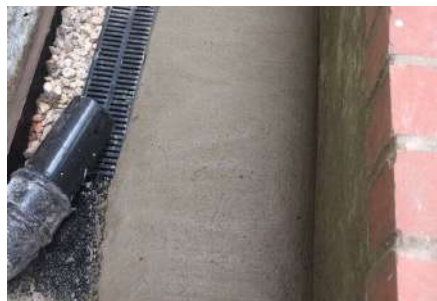
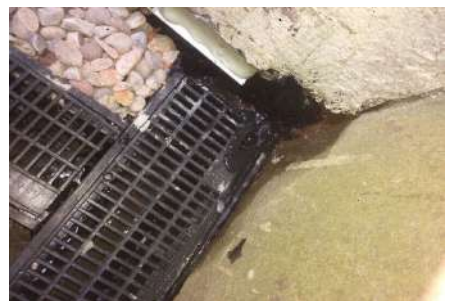
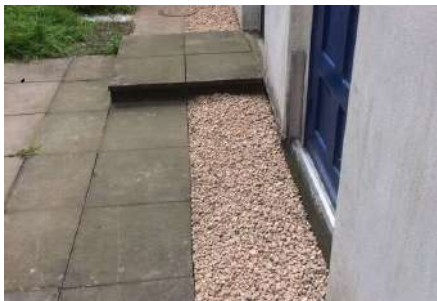
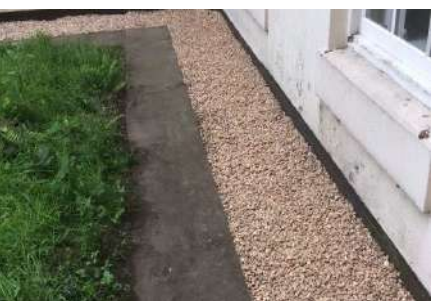
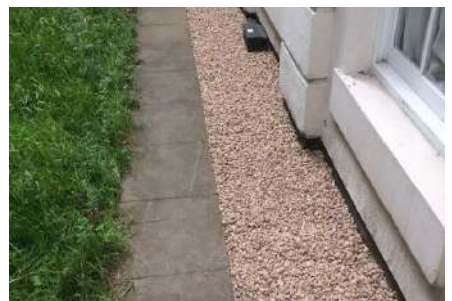
Drainage works

The main challenge of this project was that all building works had to be carried out whilst students were on site. For the external drainage works, there was limited access and unstable ground. Removal of the old plaster from the cellar walls caused massive amounts of dust in an occupied building. As for the stone steps, these had to be in use whilst works were carried out, as they were the only access to the building.

All building works were completed on time and within budget. The new ACO drains provided a natural soakaway around the perimeter of the building. All cellar walls were now fully waterproof, leaving a smooth plastered finished ready for decoration. Finally, the steps were now safe along with a high-quality stone slab finish.
